REDUCING RISKS DUE TO ROCKBURSTS: STRATEGIC FINANCIAL CONSIDERATIONS

A dissertation submitted to the Faculty of Engineering and the Built Environment,
University of the Witwatersrand, in fulfilment of the requirements for the degree of Master
of Science in Engineering.

2018

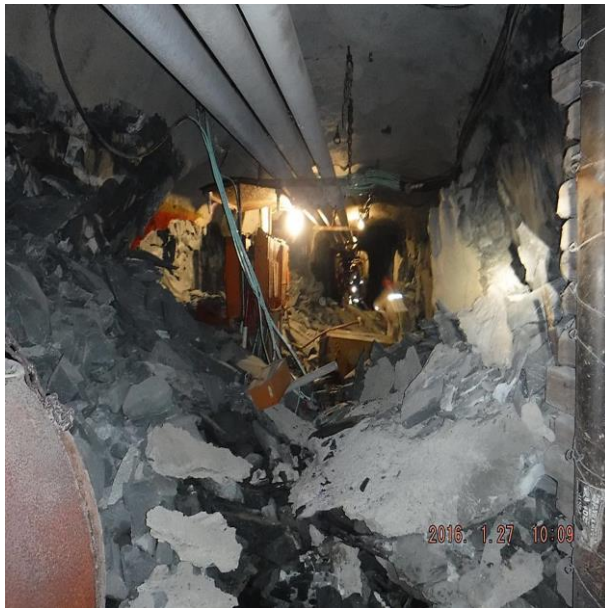
Figure 2-1: Rock material ejected from sidewalls during a rockburst event (Mine X, 2016f)

Seismic waves may result in violent ejection of rock mass on the periphery of an excavation. The damage is due to inelastic dynamic failure of the rock mass at the periphery of the excavation and is called a rockburst (Stacey, 2011; Brady & Brown, 2006). Thus, a rockburst is the displacement of rock mass due to a seismic event. Figure 2-1 below shows rockburst damage after a seismic event. In the figure, both sidewalls and their support units experienced substantial damage.

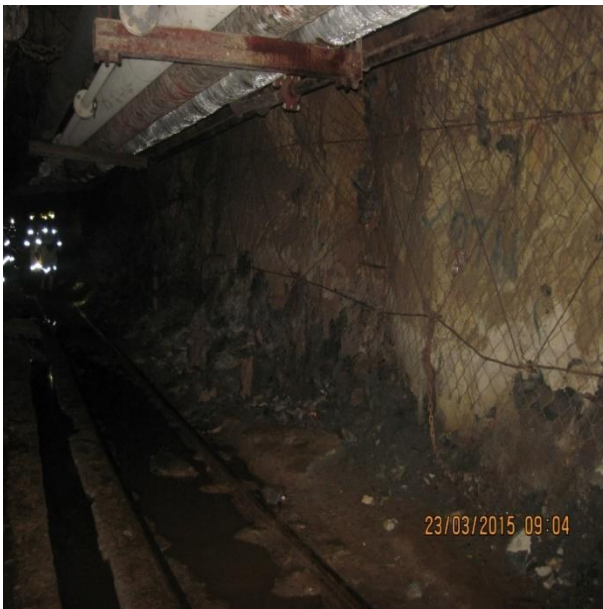
Figure 2-10: An example of dynamic support system (Mine Y, 2015)

The yielding system takes advantage of the tendons and chain-link mesh's ability to yield under stress. The system comprises of yielding tendons, tendon straps, long anchors, chain-link mesh with lacing and a layer of skin support (Stacey & Ortlepp, 2001). Figure 2-10 shows a yielding support system installed in an access tunnel.

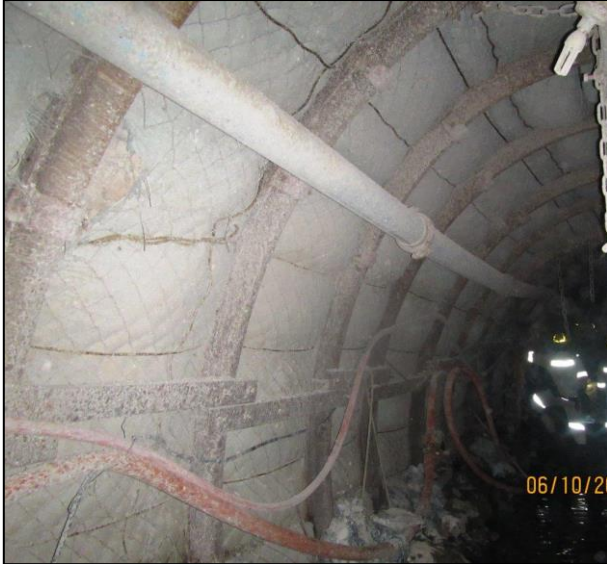
Figure 2-11: Ring steel set support system (Mine Y, 2015)

A steel set support system is suitable for weak and jointed rock conditions associated with geological features such as faults and dykes. It is often installed where the access tunnel has a known history of seismicity, is a main haulage or is the only access to a profitable raise line. This system will include yielding tendons and long anchors to provide reinforcement; chain-link mesh with lacing and yielding sets with foamcrete for voidfill to provide passive and retaining properties of the system. Figure 2-11 and Figure 2-12 show a yielding set support system.

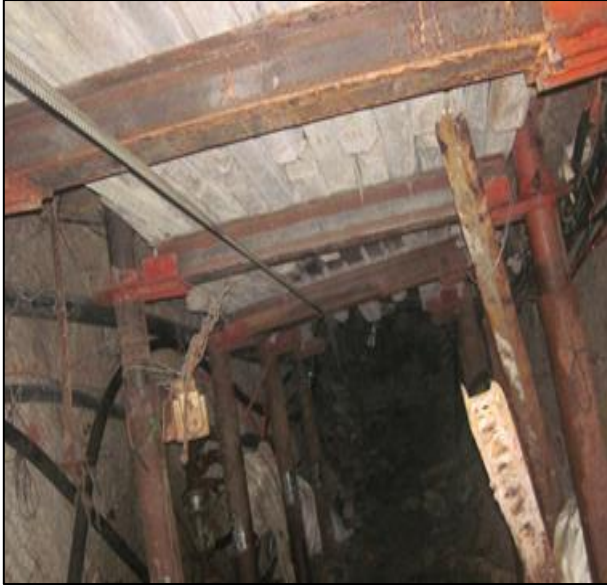
Figure 2-13: I-Beam set support system (Mine X, 2009)

Figure 2-13 shows a representation of an I-beam set support system that is considered a less costly version of the yielding set support system. This system consists of rigid tendons, long anchors, I-beams and wooden laggings and sometimes voidfill. This system is a rigid variation of the set support system.

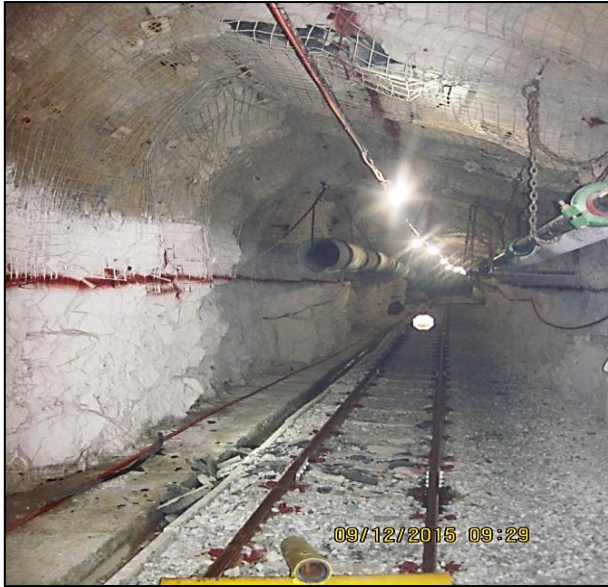
Figure 2-14: Installed rigid support system (Mine Y, 2015)

For the purpose of this study, this system will include rigid tendons and long anchors to provide reinforcement; spiral bound welded mesh and a layer of shotcrete. This system is suitable for environments under static loading conditions. Figure 2-14 shows an example of an installed rigid support system.

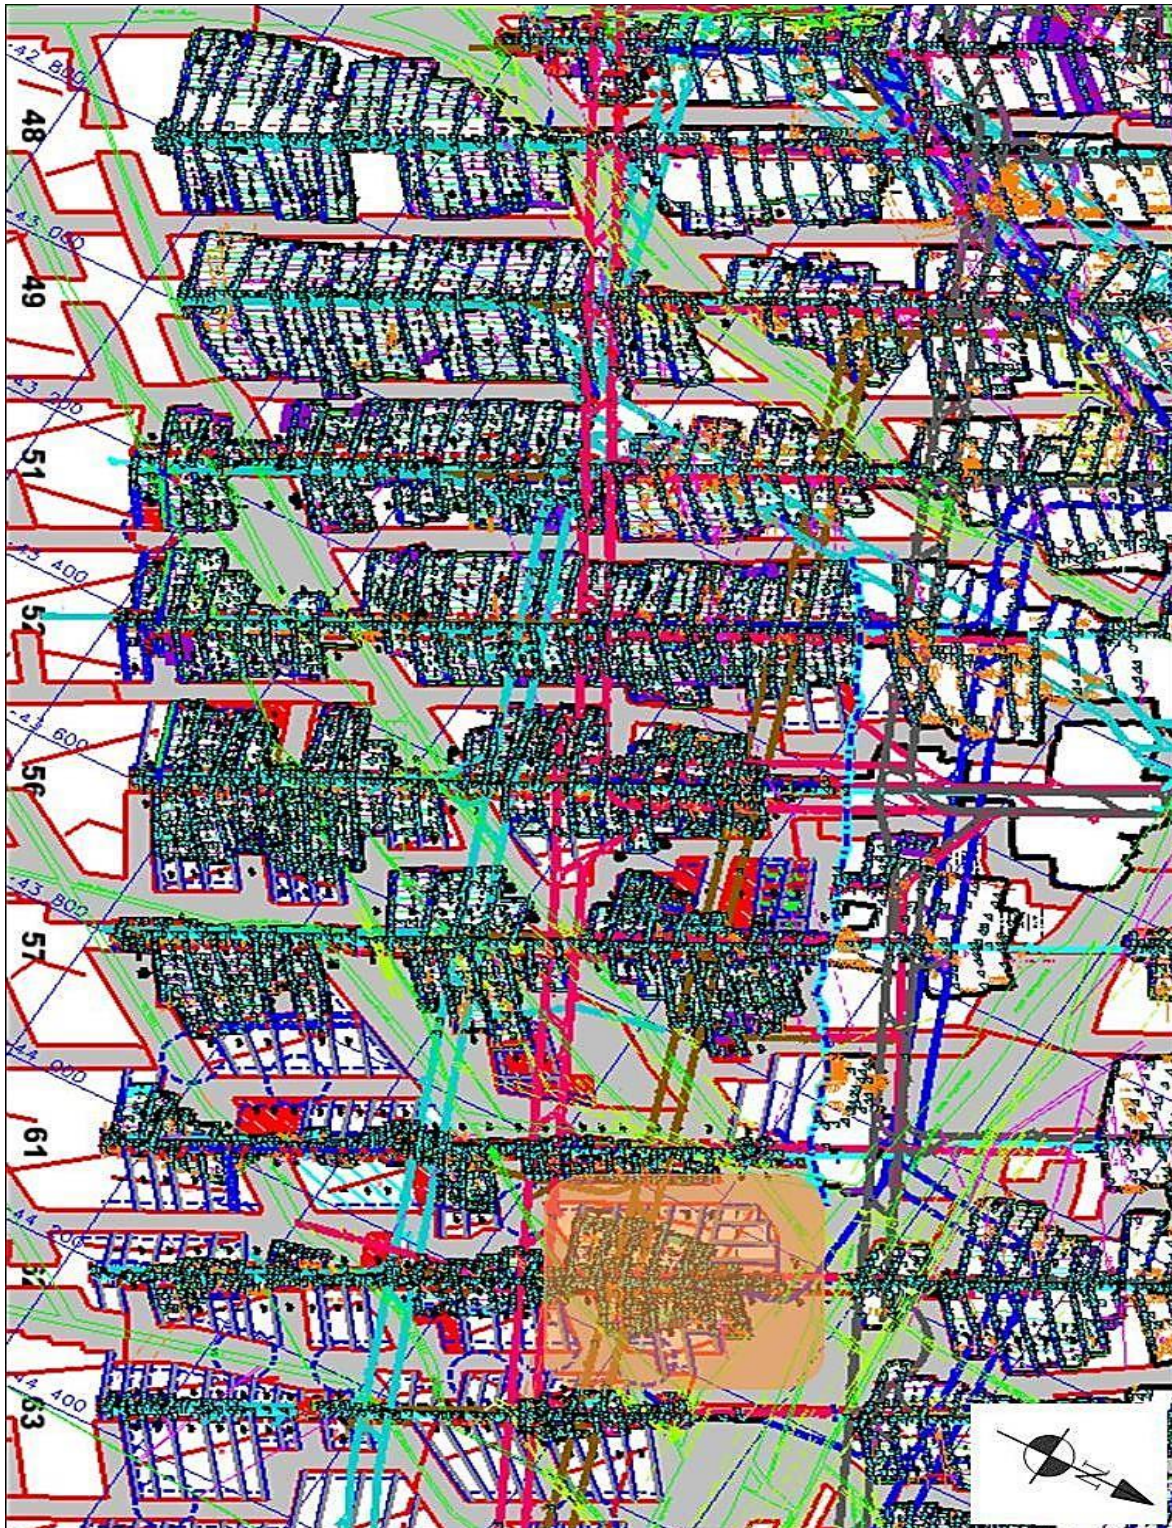
Figure 3-1: Plan view of a sequential grid mining layout (Mine X, 2016f)

Figure 3-1 shows a plan view of a sequential grid mine layout implemented at Mine X. The structures indicated in green are dykes, faults are indicated in magenta and unmined areas are indicated in grey. The grey unmined ground is concentrated around geological structures and it indicates bracket pillars around the geological structures.

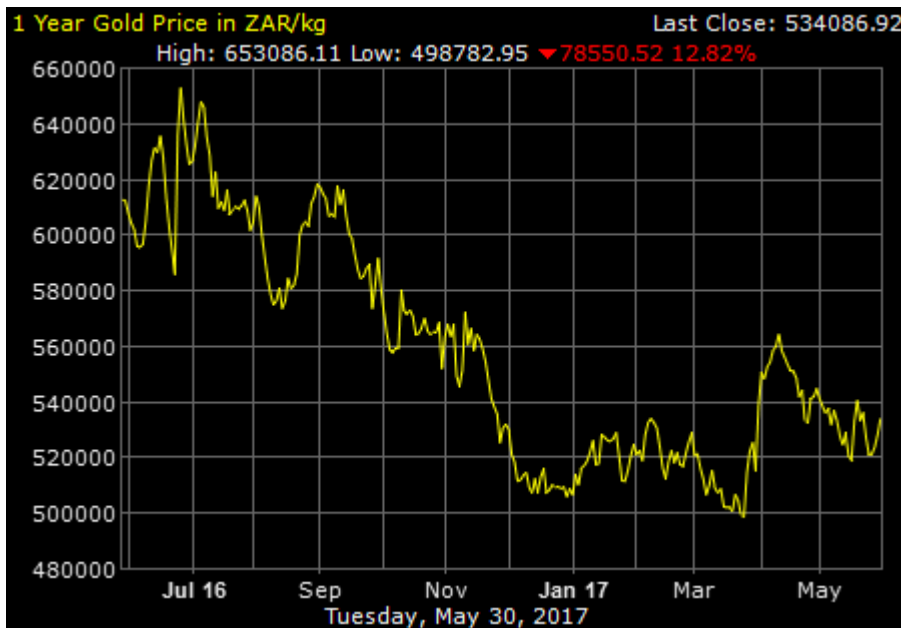
Figure 3-7: Gold price in R/kg over the last year (GoldPrice, 2017)

- There are three production crews working in a raise line at any given time
- Each crew has a 400 t monthly target, therefore a 100 t weekly target
- The gold grade is 10 g/t
- The operation has a built-in flexibility
- The average for moving out of an affected panel and establishing a new panel is three weeks
- The effective gold price (regardless of year of rockburst) is R 575 000, 00/kg. The price is derived from the gold prices in 2016 as shown in Figure 3-7. This enabled the evaluation of costs as near net present value as possible.

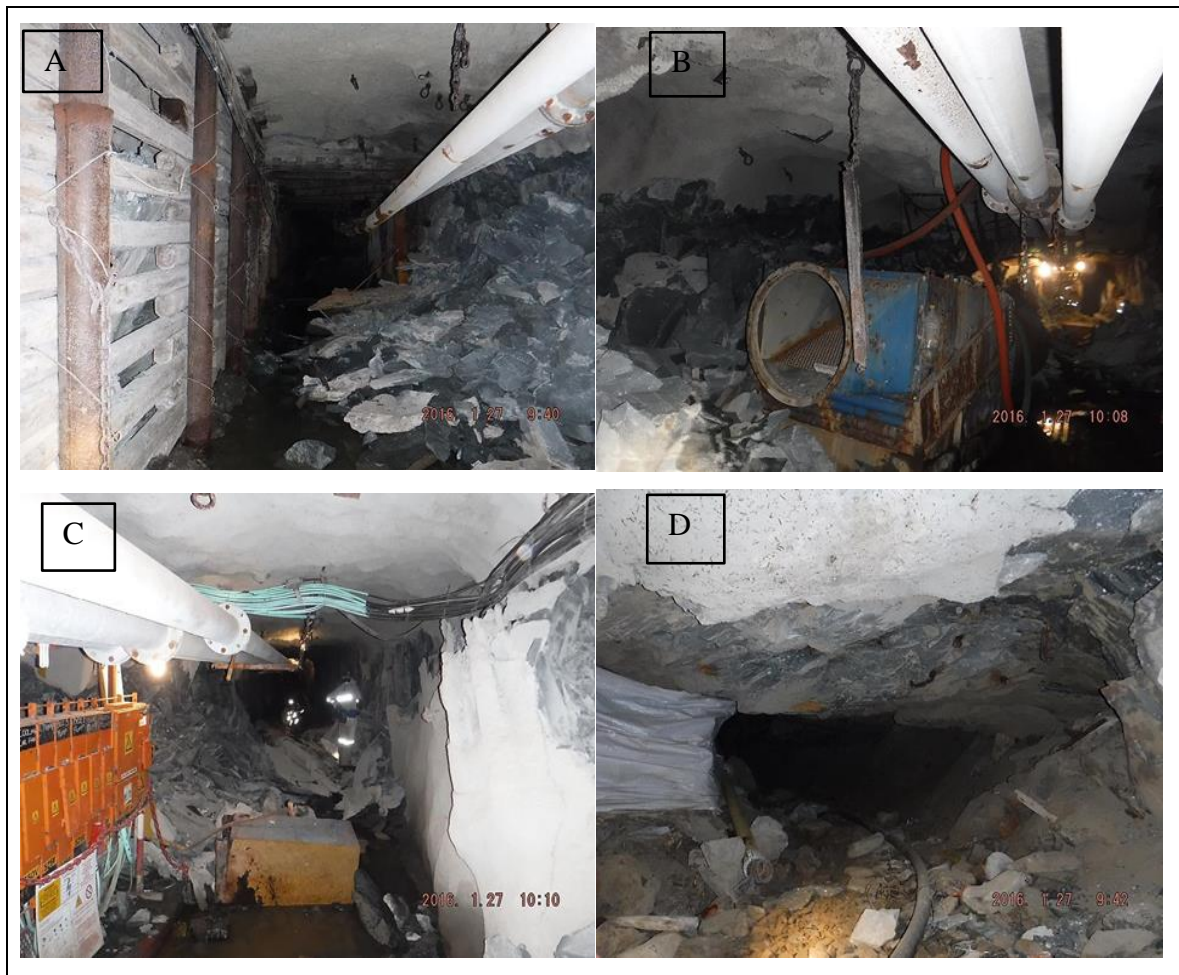
Figure 4-1: Pictures of rockburst damage. (Mine X, 2016f)

The portion of the tunnel that failed was supported only with primary support. The primary support comprised of 2.1 m splitsets and steel-fibre reinforced shotcrete. While the part of the tunnel support with I-Beam sets did not experience damage. The picture on the left in Figure 4-1A shows RSJ support across from across the cooling car in cubby, the sidewall behind the cooling car had extensive rockburst damage as shown in Figure 4-1A and B. Figure 4-1C shows damage on both sidewalls in the crosscut. Figure 4-1D shows damage near the reef intersection.

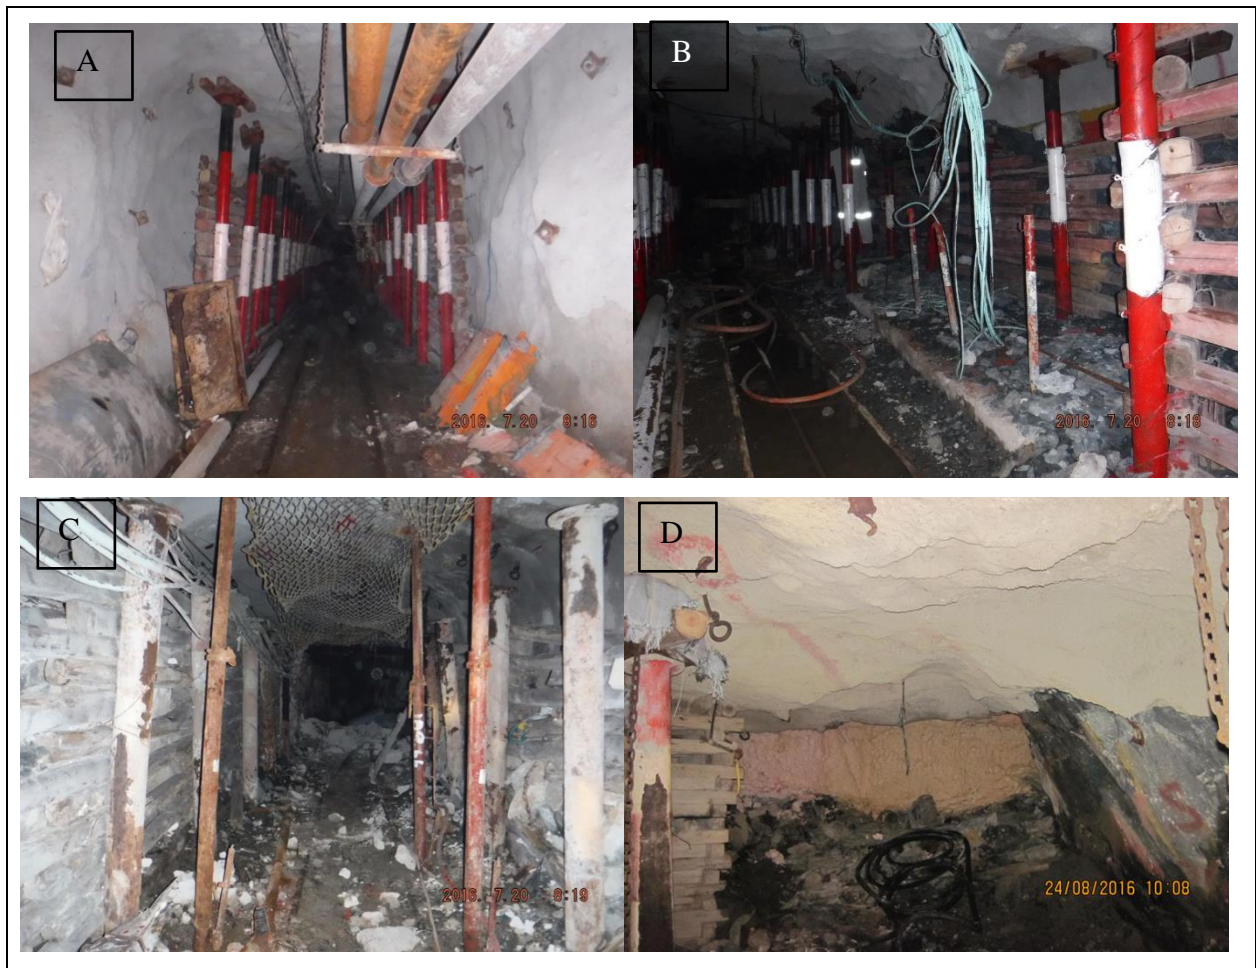
Figure 4-2: Pictures of the rehabilitated crosscut (Mine X, 2016f)

Figure 4-2A and B show support installed along the cross cut as recommended. In Figure 4-2C, the hangingwall was supported with an additional chain-link mesh attached to the roof with shepherd crooks and laced on a 1.5 m diamond pattern. The reef intersection was closed off as shown in Figure 4-2D.

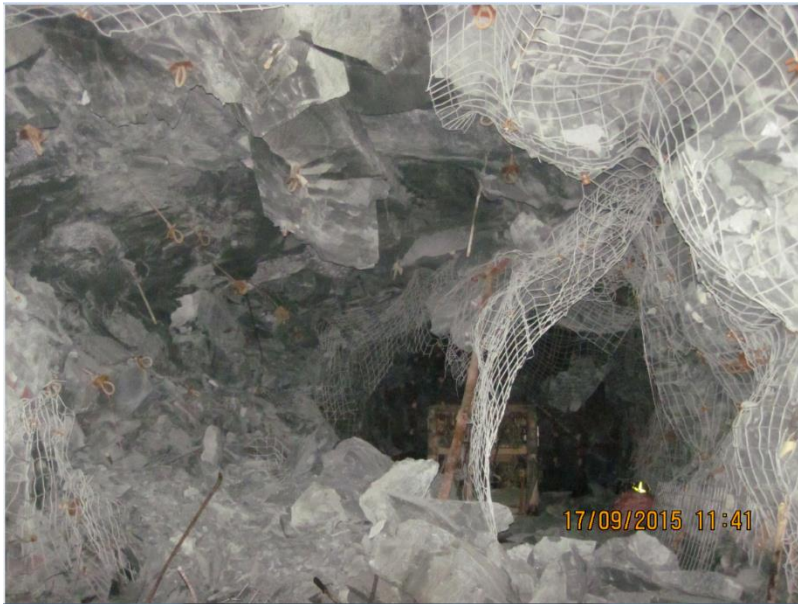
Figure 4-9: Rock mass ejected from the sidewall of the development end during the rockburst (Mine Y, 2015)

Figure 4-9 shows the damage experienced in the development end due to the rockburst. Failed rigid tendons and welded mesh are visible in the image. The locomotive used to transport waste rock is trapped near the development face.

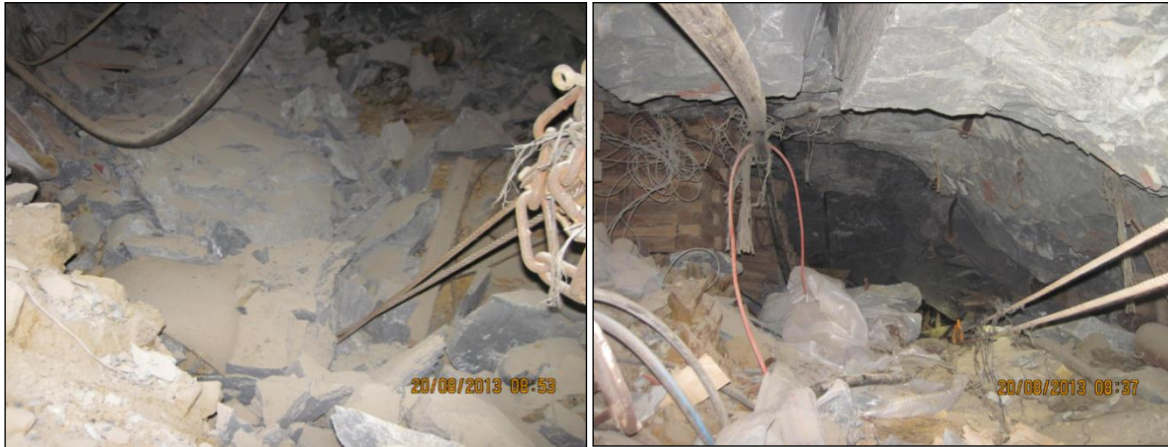
Figure 4-18: Blocked monowinch travelling way (Mine X, 2013)

Figure 4-18 shows the blocked holing of the monowinch travelling way, with riggings and ropes trapped by broken rock mass.
